# Safety works for the Rhone levees from Beaucaire to Arles 2007-2022

A PUBLIC INSTITUTION FOR MANAGEMENT OF RIVER AND SEA LEVEES IN THE RHÔNE DELTA

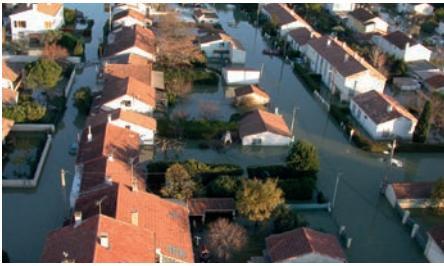
2003 - Arles

The last flood was the December 2003 one.

- **11 500** m<sup>3</sup>/s estimated discharge
- < 100 years (return period)</p>
- 227 million m<sup>3</sup> water spilled
- **4** breaches

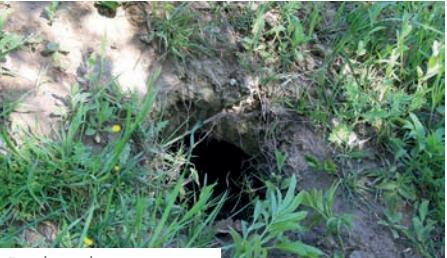
This intrinsic fragility is worsen by frequent badgers burrows and

Badger burrow

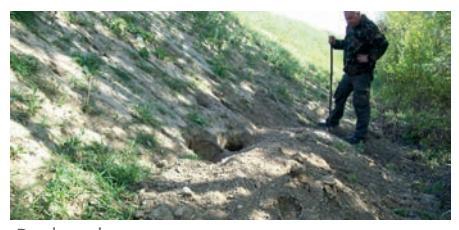
a concentrated leak erosion in a former badger burrow partially clogged and not visible;

Badger burrow

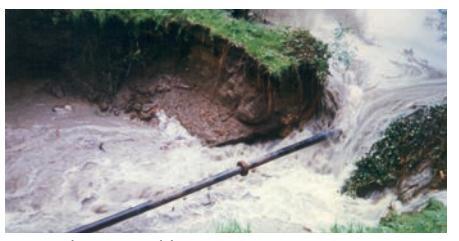
- a concentrated leak erosion along an existing hole between a crossing structure and the levee embankment;
- an **overflow** on the levee.

Breach caused by a crossing pipe

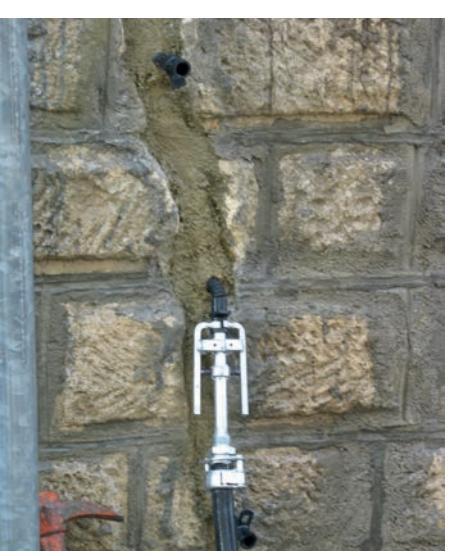
Banquette levee, clogged crack

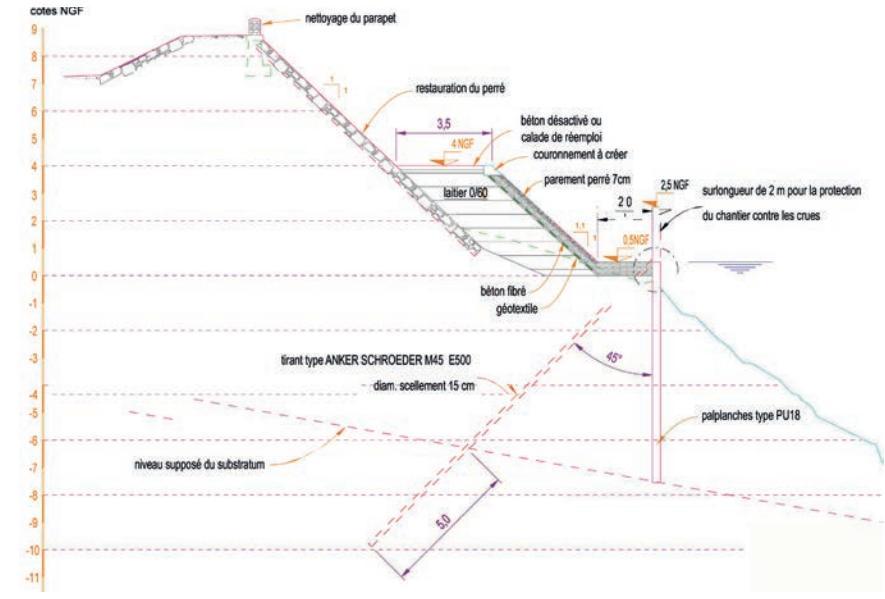
Typical cross-section Max Dormoy quay\* (see glossary on last page)

The Rhone speed, very important crossing Arles, linked to the narrowing of the river, have eroded the bottom of the riverbed and led to the formation of an erosion pit destabilising quays foundations, resulting in the progressive ruin of the works by successive collapses.

- Repair the collapsed parts.
- Threshing a sheet pile curtain at the foot of the levee.
- Masonry repair.
- Cofferdams modernisation.

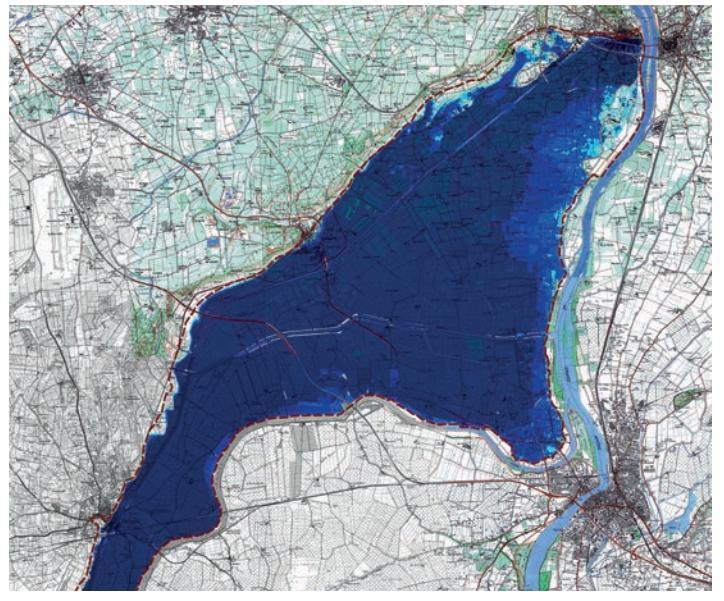
Breach, almost certain, before the works between Beaucaire and Fourgues

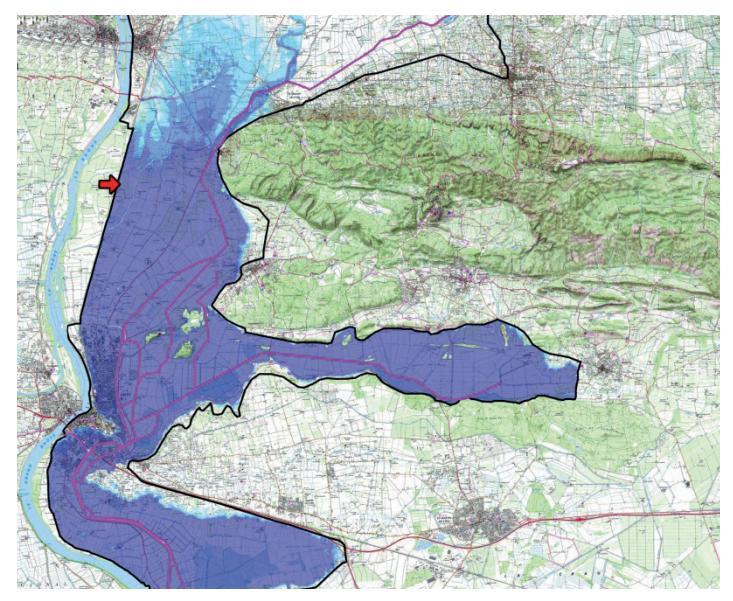
Breach, almost certain, before the works between Tarascon and Arles
