# Safety works for the Rhone levees from Beaucaire to Arles 2007-2022

A PUBLIC INSTITUTION FOR MANAGEMENT OF RIVER AND SEA LEVEES IN THE RHÔNE DELTA

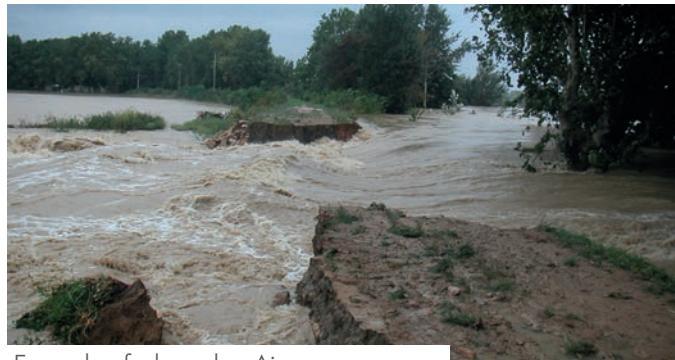
Example of a breach – Aimarques

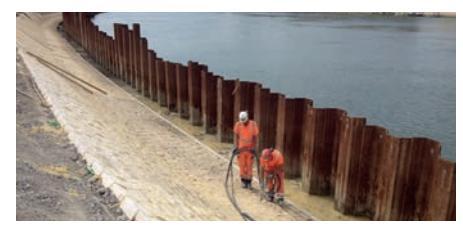
Arles quays, facing

For the masonry levees, the waterproofing consisted of fully taking over the siding masonry by plugging first the cracks, or by carrying out a new siding in shotcrete on the siding already concreted.

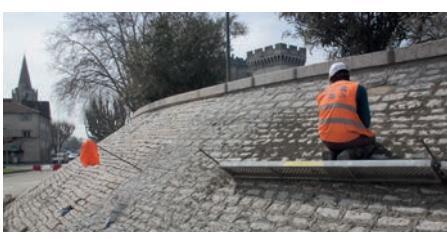
Montagnette levee, joining

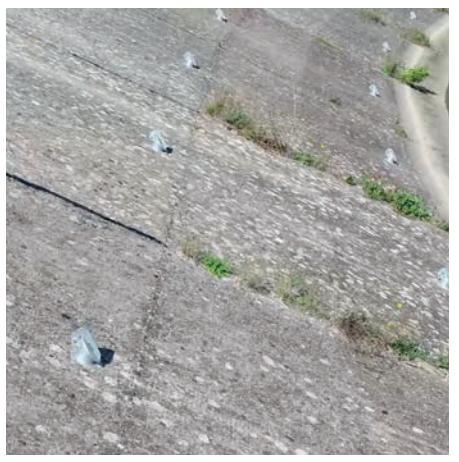
Drainage outlet, Boulbon spillway

For the masonry levees, this can pass by a drilling of the facing, on the landward side, to improve the ability to drain possible seepages and to dissipate pressures within the embankment.

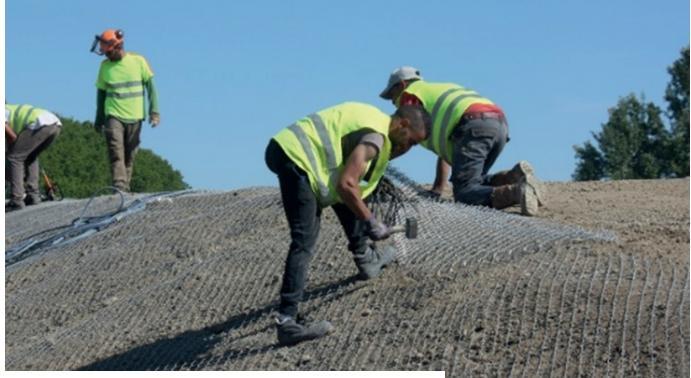
Installation of anti-burrowing mesh

The filter is stabilized to avoid its uplift by an embankment shoulder on landward side, in case of an under pressure. Slopes are softened. Furthermore, a protection against the burrowing animals has been implemented to avoid new burrows creation.

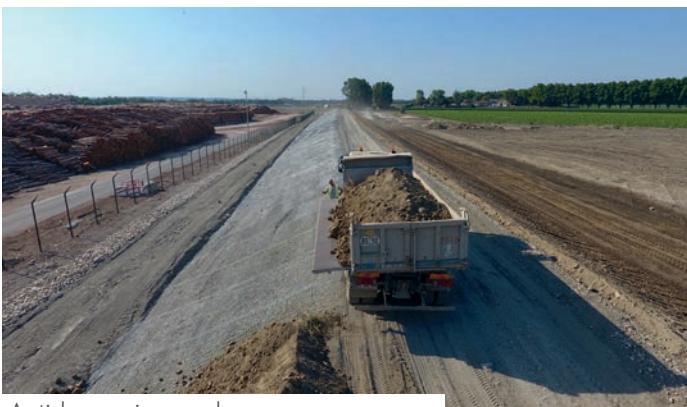
Anti-burrowing mesh

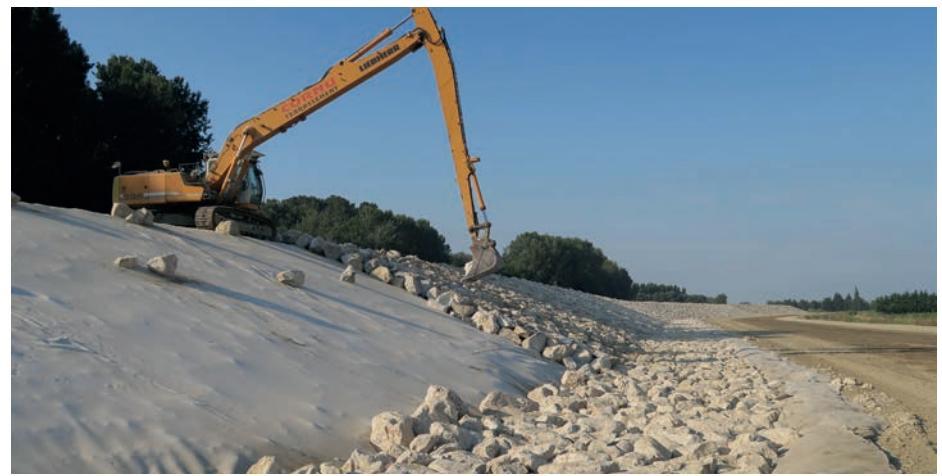
Laying of 200 to 400 kg riprap

For the levees resisting to overflow, the landward side is reinforced with concreted riprap, so as to resist to high speeds, in case of overflow. Upstream and downstream spillways, the levees are set 50 cm above the millennial flood level to avoid a risk of circumvention in case of overflowing (construction steps beside).

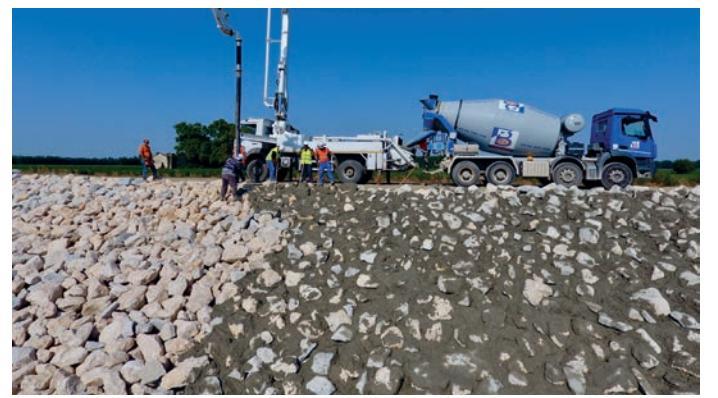
Concreting of riprap

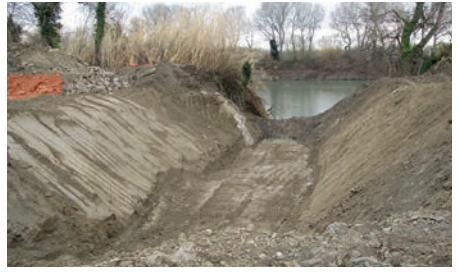
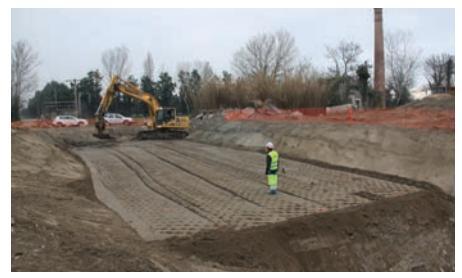
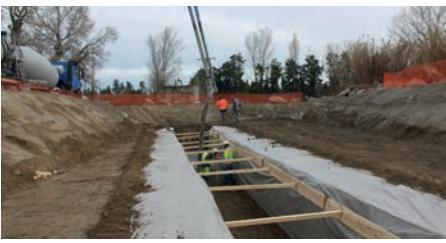
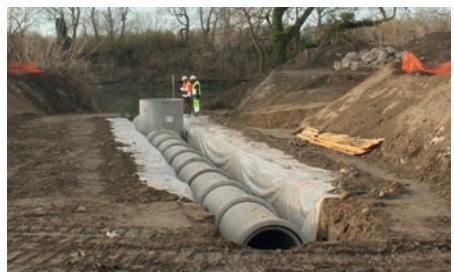
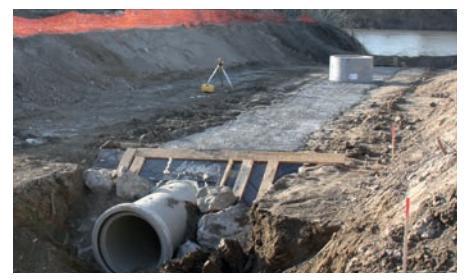
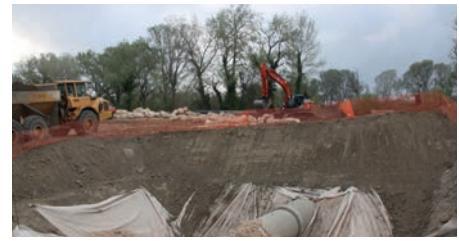
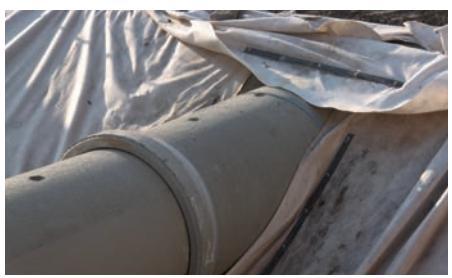
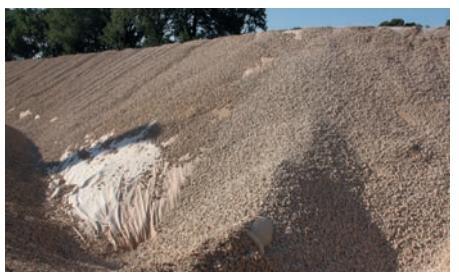
The hydraulic structures crossing levees, represent a weak point for the flood defence system (20% of breaches by internal erosion). They can constitute preferential passages for water during floods between the crossing structure and the levee embankment. It is therefore essential to secure these crossings by well-designed works.

1 - Opening of excavations

2 - Compaction of the foundation base

3 - Trenching and concreting of the excavation bottom

4 - Laying of the pipe

5 - Full excavation and coating concreting

6 - Installation of the filter and downstream drain

7 - Pipe filter link

8 - Realisation of downstream drainage

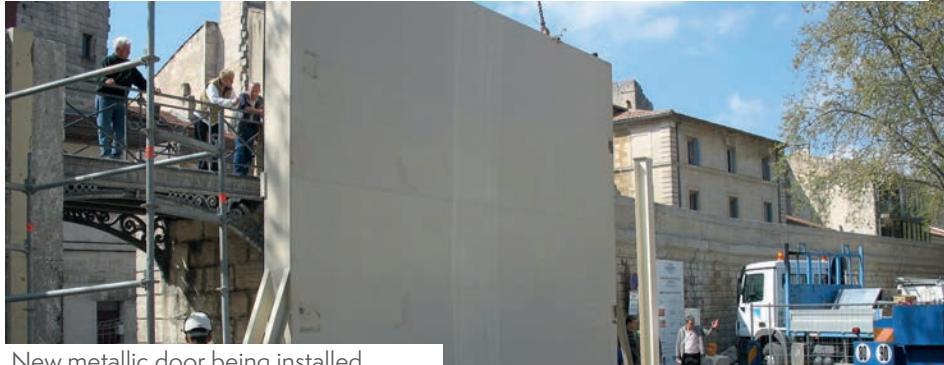
The diagnosis before work showed weaknesses of the levee and a lack of height on its securing doors, despite good general condition.

- Cracks sealing on the facing river side to improve airtightness.
- Drillings on the facing city side to • improve drainage of possible infiltrations.
- Change and enhancement of the metallic doors.
- Reconstruction of the parapet • upstream.
- Modernisation of the car passages where cofferdams can be installed.

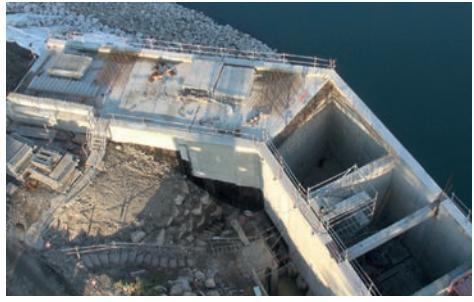
Fourgues levee – December 2003
